# Hydrothermal Alteration of Cementitious Materials Part II: Second and Third Batch of Samples

K.B.L. Myers  
A. Meike

October 25, 1997

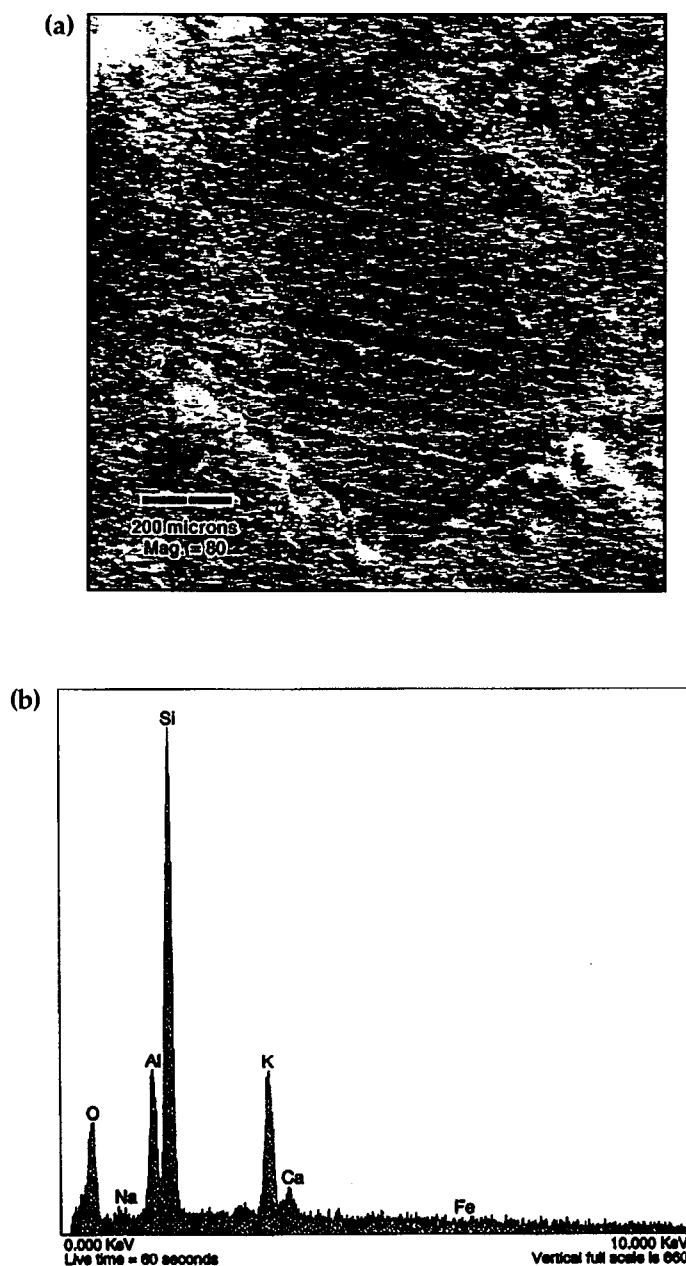
**Figure 38.** SH-9 (PV-13-9). (a) SEM photomicrograph of an aggregate grain. Closer examination around the grain edge does not reveal reaction phases. (b) EDS of the grain indicates the presence of Si, Al, O, and K with minor amounts of Ca and Na, possibly a potassium feldspar grain.

**Shotcrete.** The surface alteration on sample SH-9 (PV-13-9) is similar to that in the other dry treated samples. Several Ca-Si phases occur as alteration rims on grain boundaries, and several occur on grout. This sample also has a steel fiber that shows no reaction phases or alteration (Figure 35) and a carbonate phase that occurs in and around the drilled-out hole in the center of the sample (Figure 36). Feldspar grains were found both with reaction phases (Figure 37) and without (Figure 38 and Figure 39).

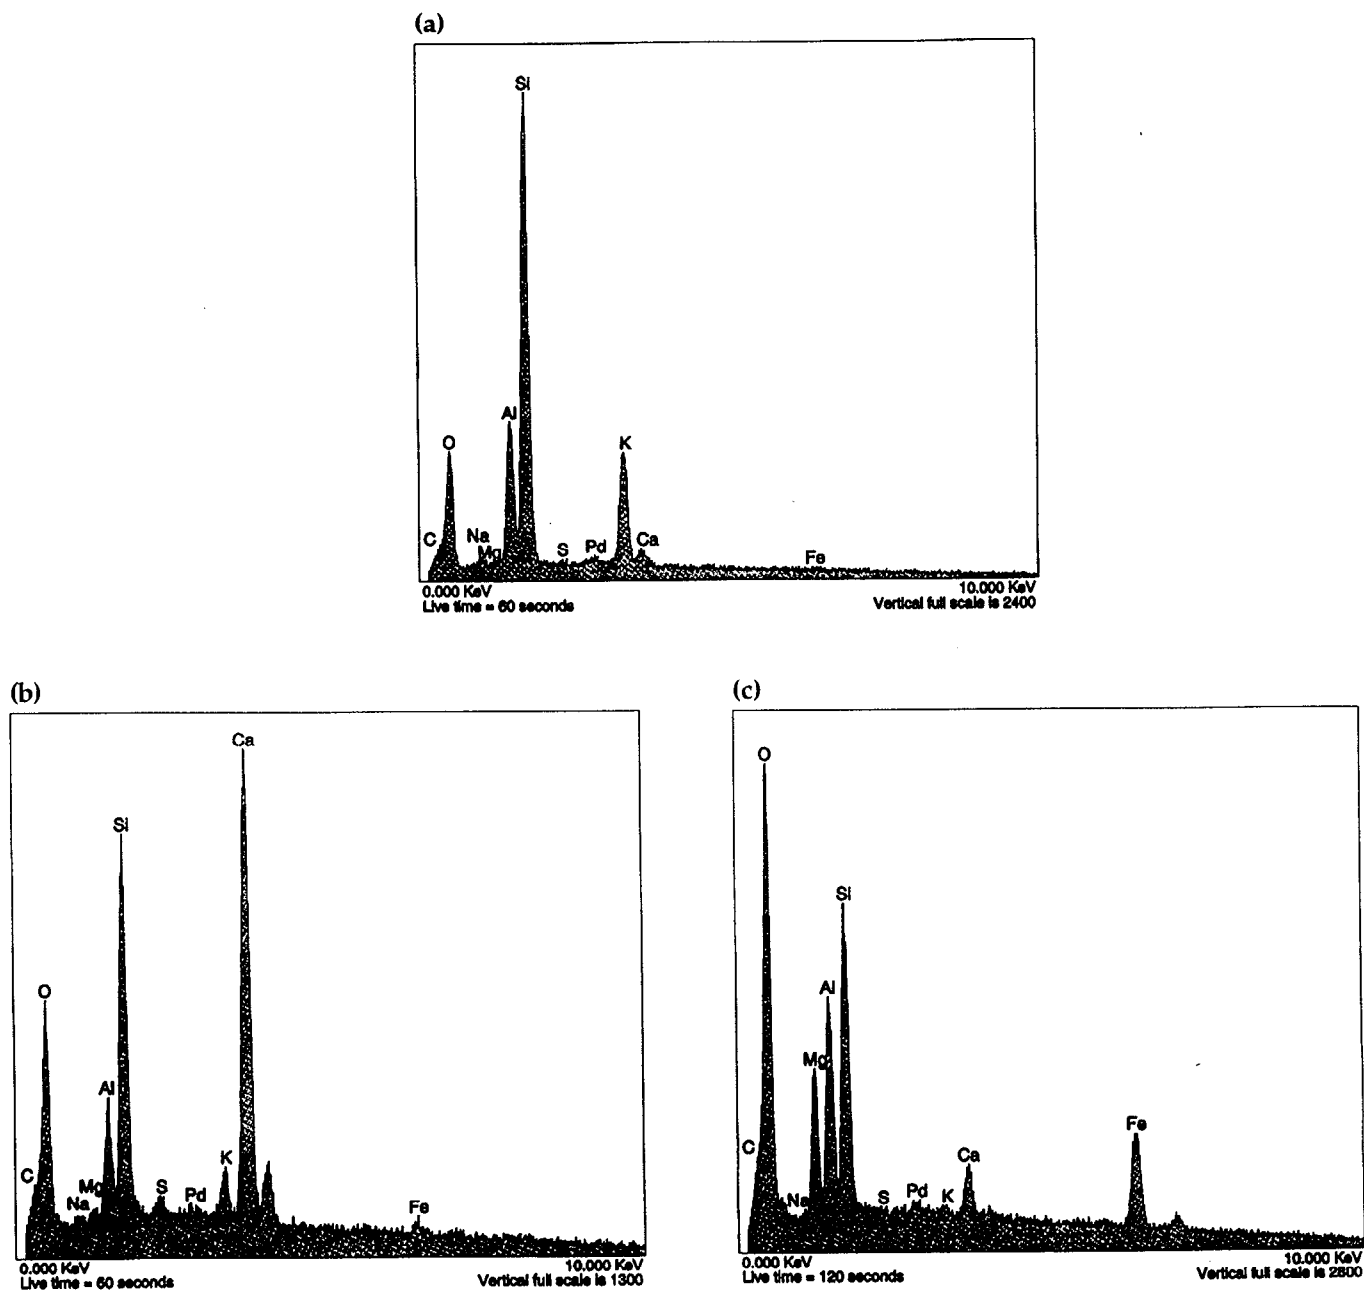
**Figure 39.** SH-9 (PV-13-9). (a) No photomicrograph observation of relationship between secondary mineralization and primary material. EDS of the interior of a grain surrounded by secondary minerals located adjacent to the central hole. The spectrum indicates the presence of Si, Al, O, K with minor Ca. The grain is probably potassium feldspar. (b) EDS of grout with no visible reactant phases located near the central hole. The spectrum shows the presence of Ca, Si, O, Al, and K with minor amounts of S, Fe, C, and Mg. (c) EDS of a grain located between reaction phases shown in Figure 36(a) and the grout described in Figure (b). The spectrum indicates the presence of O, Si, Al, Mg, Fe, and Ca. The grain is probably a pyroxene or amphibole.

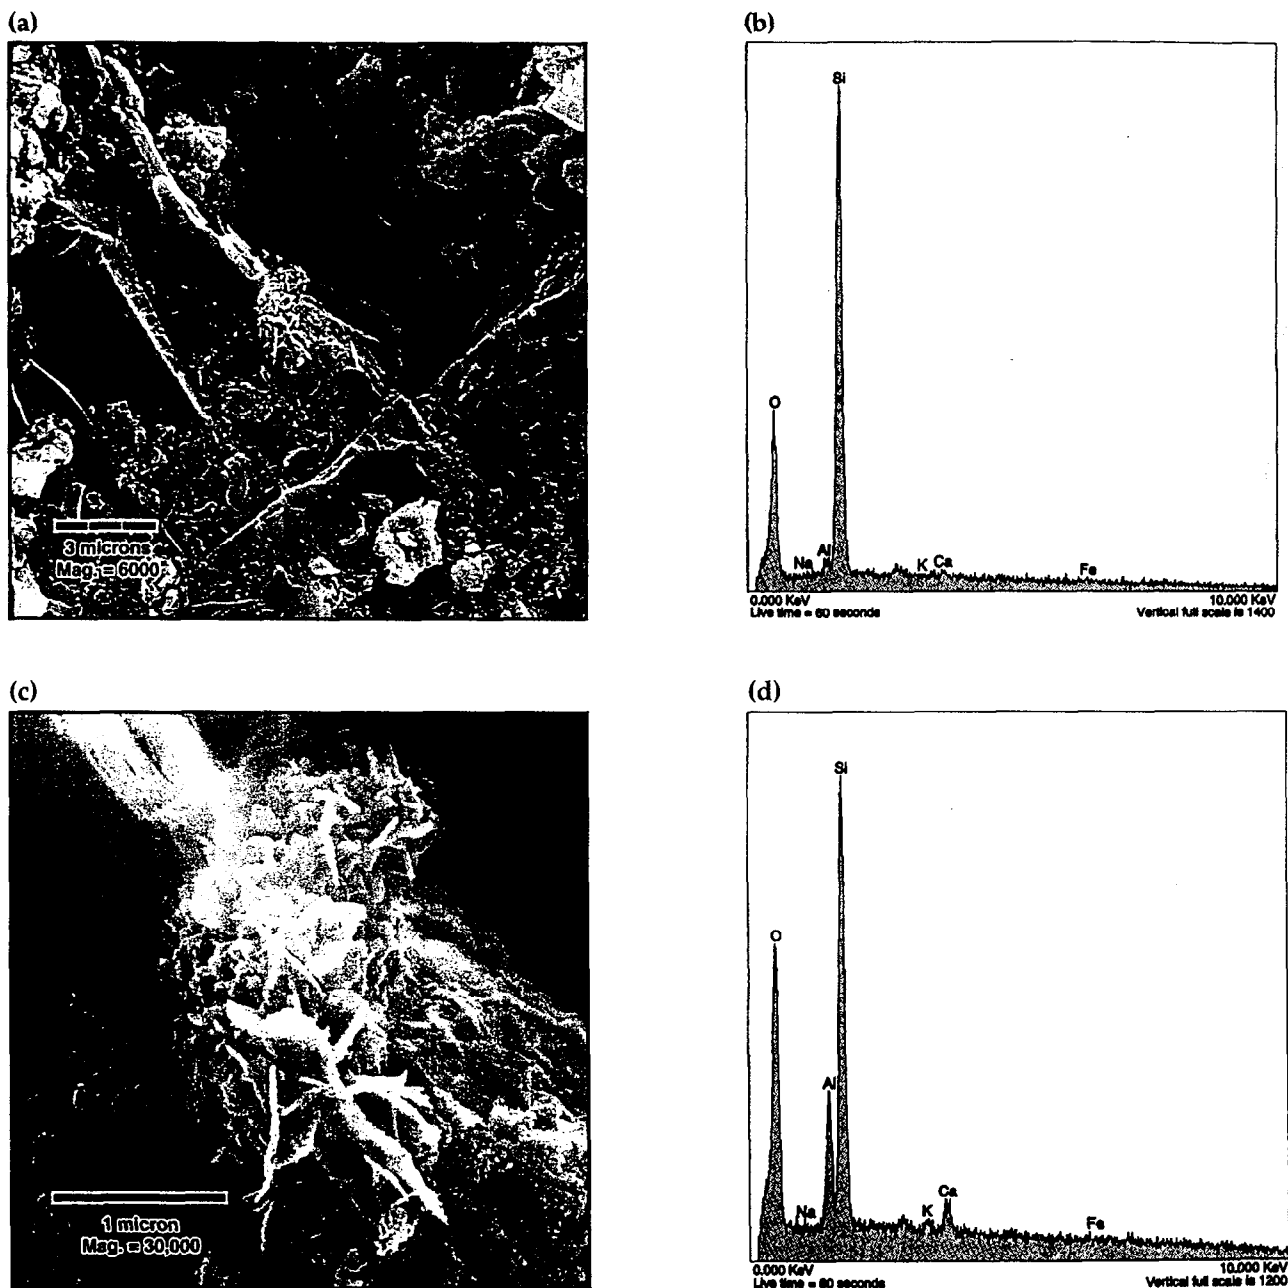
Figure 40. SH-9 (PV-13-9). (a) SEM photomicrograph of a tiny platy phase (see center of photo). (b) EDS of the area indicates that the tabular phase has precipitated on a grain composed of  $\text{SiO}_2$ , probably quartz. The quartz grain likely makes up the majority of the x-ray volume. (c) SEM photomicrograph of the platy phase at higher magnification. (d) EDS of the platy phase indicates the presence of Si, O, and Al, with minor amounts of Ca. The underlying quartz grain likely contributes most of the signal in this spectrum.

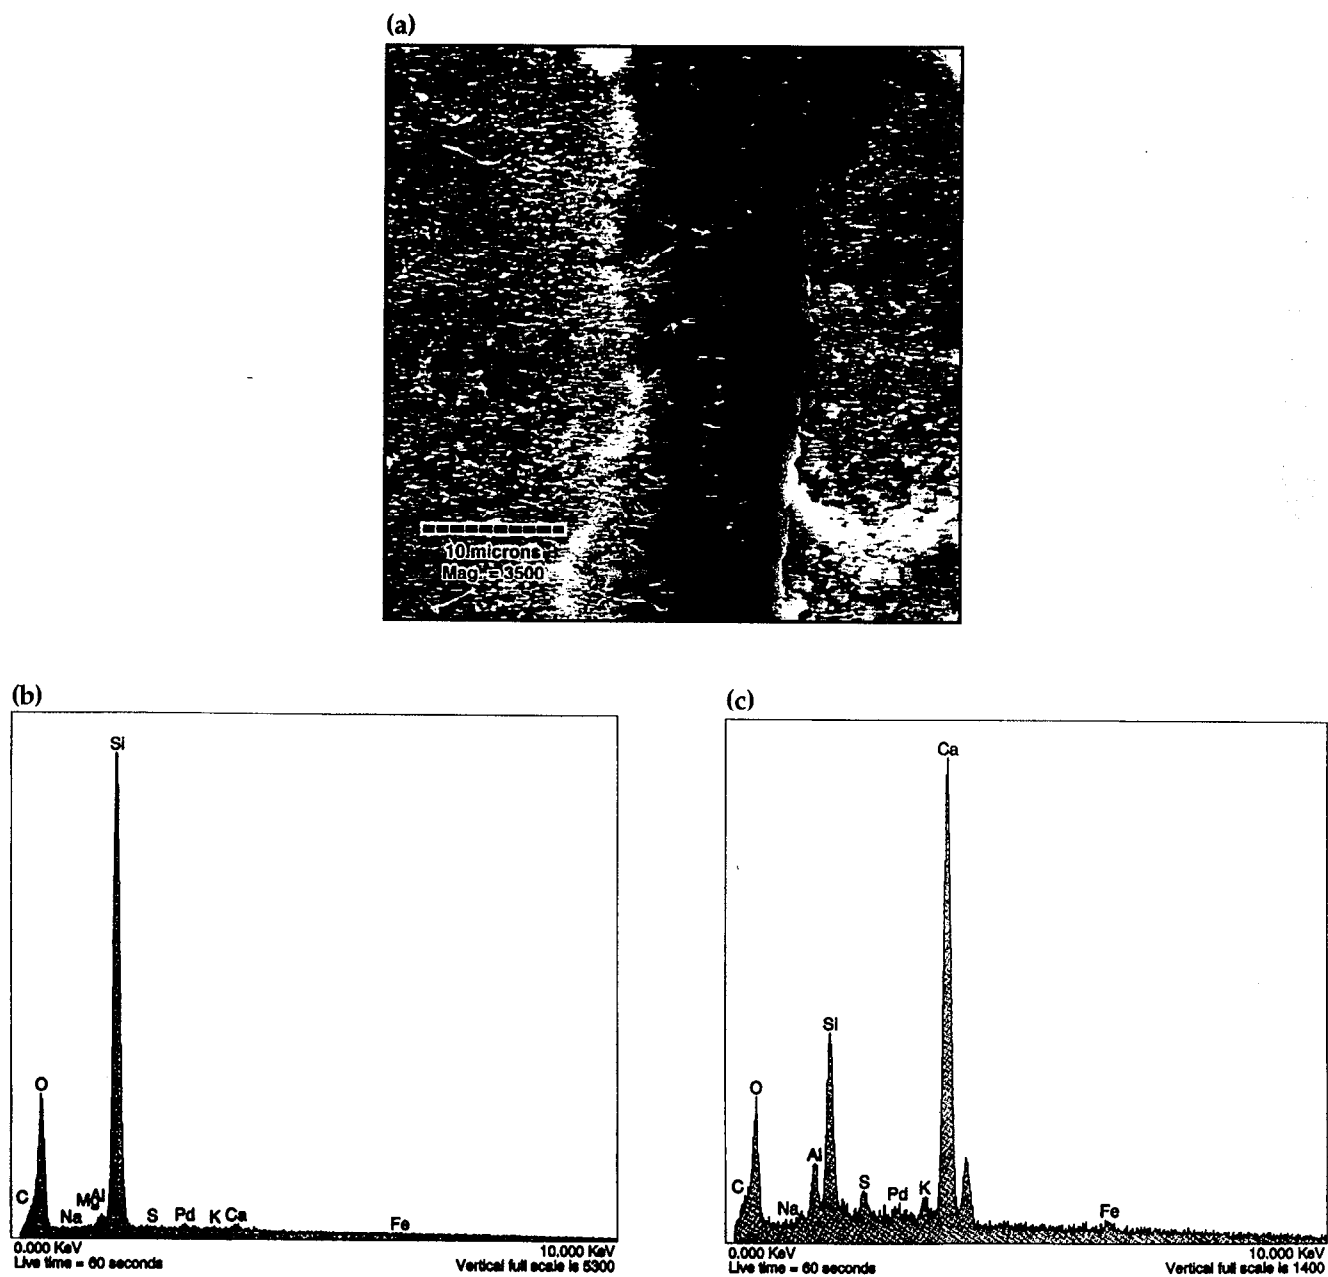
**Figure 44.** SH-9 (PV-13-9). (a) SEM photomicrograph of an aggregate grain (left side) with a white, stringy phase and band of black glassy material. (b) EDS of the aggregate grain indicates that it is quartz or another  $\text{SiO}_2$  phase. (c) EDS of grout outboard of the quartz grain and reaction phases. The spectrum suggests Ca, Si, and O, with minor amounts of Al, S, and K.

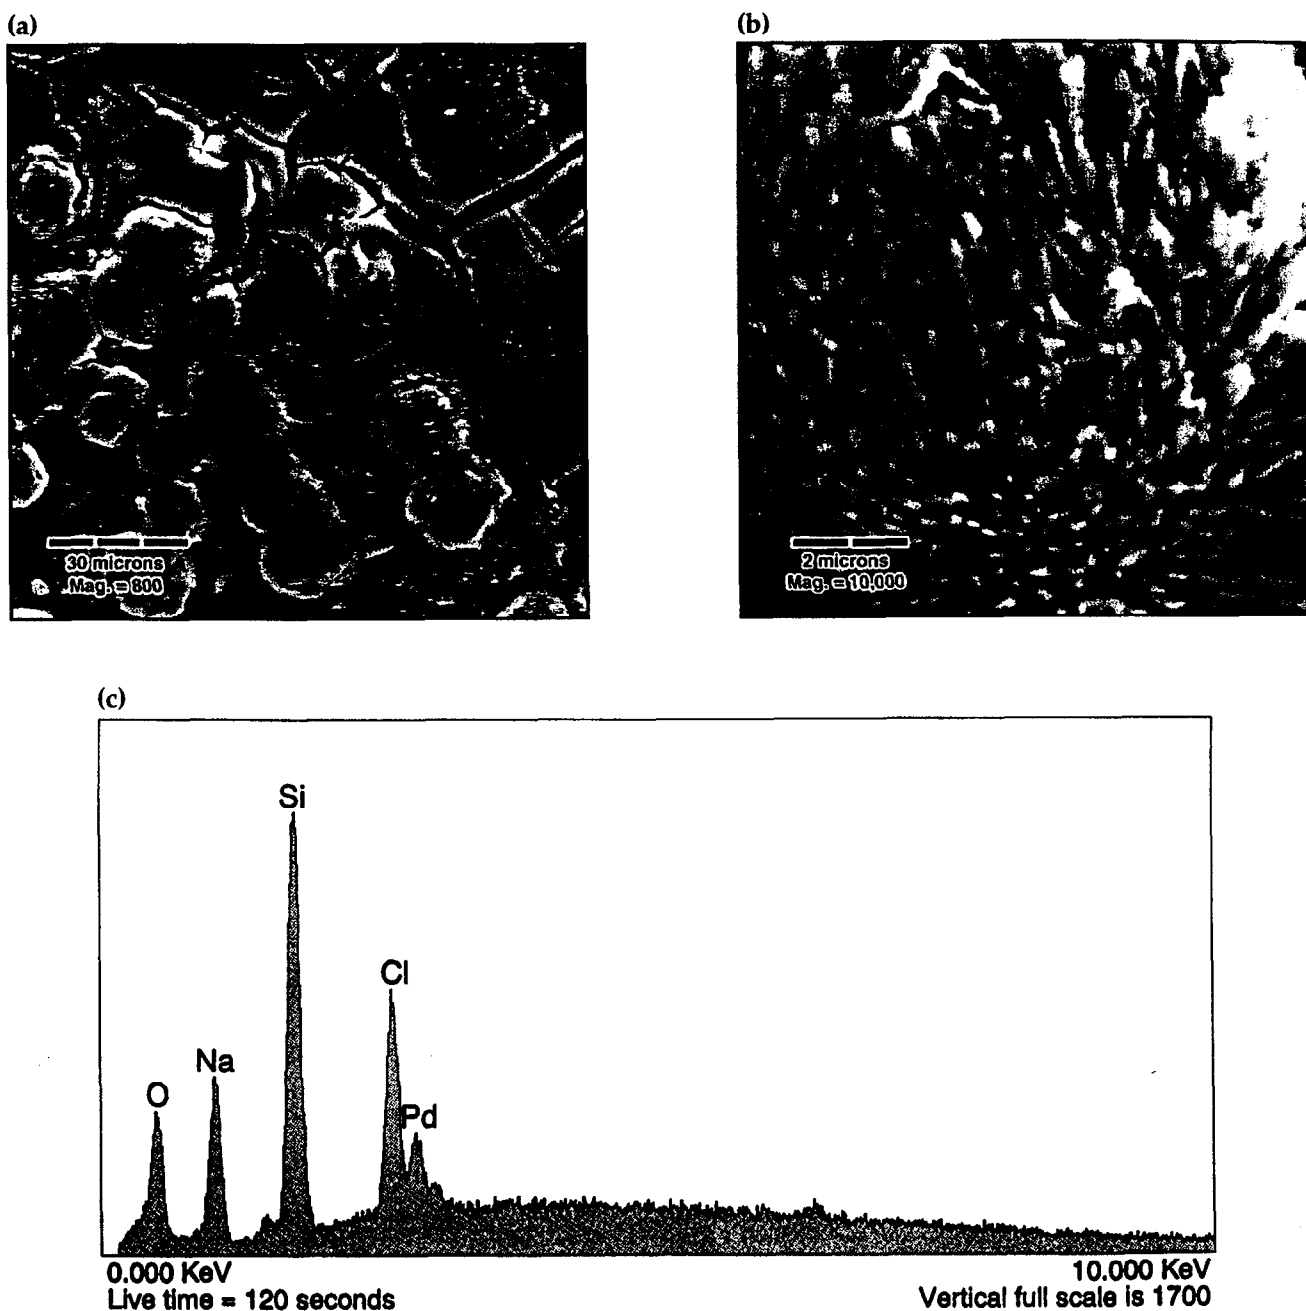
**Figure 51.** INV-23A, side 1 (PV-18-23a). (a) SEM photomicrograph of the various textures that occur as a white crust on the sample. (b) SEM photomicrograph of a phase that resembles fibrous clumps. (c) EDS of the fibrous phase suggests Si, Cl, Na, and O.

Side 1 had an abundance of white crust coating most of the surface, on which at least four morphological textures can be observed (Figure 51a). One of these phases (Figure 51b) resembles fibrous clumps. EDS of the fibrous phase (Figure 51c) suggests the presence of Si, Cl, Na, and O. A second phase that occurs in the white crust is a globule-shape (Figure 52a), and EDS (Figure 52b) suggests the presence of Si, O, Na, Al, and Cl. A third phase (Figure 52c) is typical of the smoother areas of the white crust, and EDS (Fig 52d) suggests the presence of Si, Cl, Na, and O. Figure 53a is an SEM photomicrograph of a rhombohedron poking through the white crust. EDS of the rhombohedron (Figure 53b) suggests the presence of Ca, Si, O, Cl, and Na. Figures 54a and 54b illustrate two acicular phases that occur in the crust. EDS of the phase shown in Figure 54b suggests the presence of O, Na, and Si. Figure 55a is an SEM photomicrograph of a needle-shaped phase that has a square cross-sectional shape. EDS (Figure 55b) of the needle-shaped phase, where it occurs on an aggregate grain, suggests the presence of O, Na, and Si. EDS (Figure 55c) of an area adjacent to the needle-shaped phase suggests the presence of O, Na, and Si.

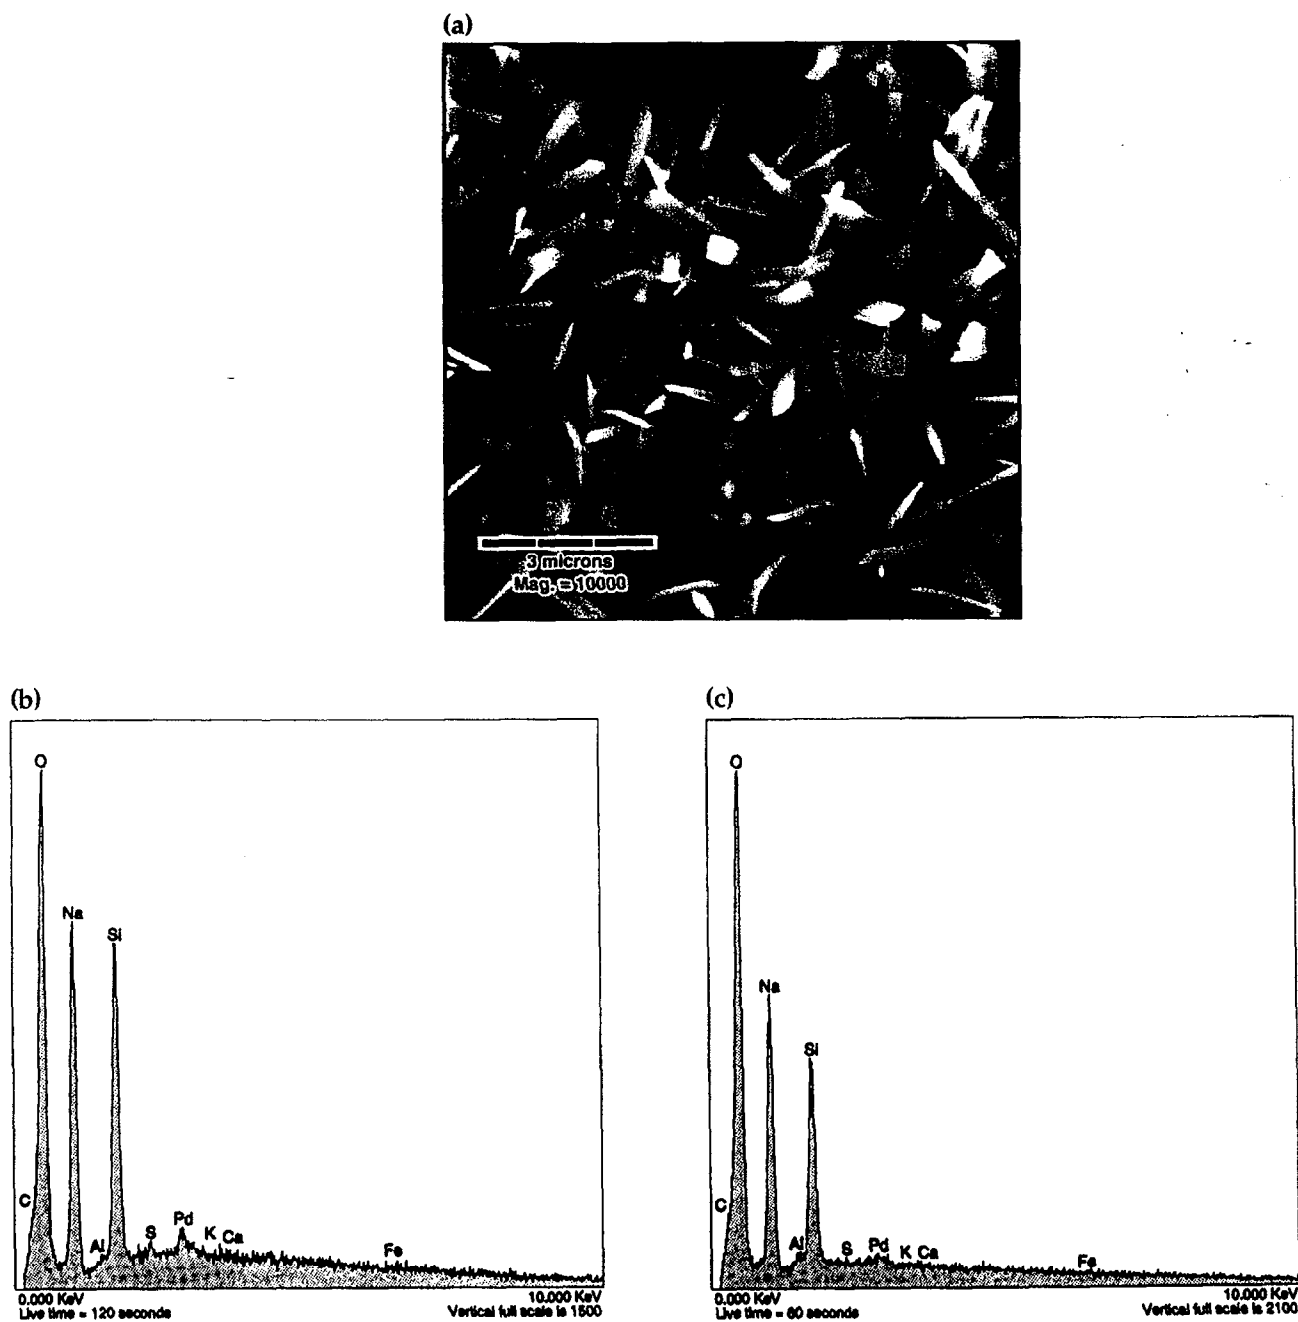
**Figure 55.** INV-23A, side 1 (PV-18-23a). (a) SEM photomicrograph of a needle-shaped phase that has a square cross-sectional shape. (b) EDS of the needle-shaped phase where it occurs on an aggregate grain suggests O, Na, and Si. (c) EDS of an area adjacent to the needle-shaped phase suggests O, Na, and Si.
